FRCSW Inducts Its First CMV-22 to Suffer Mishap

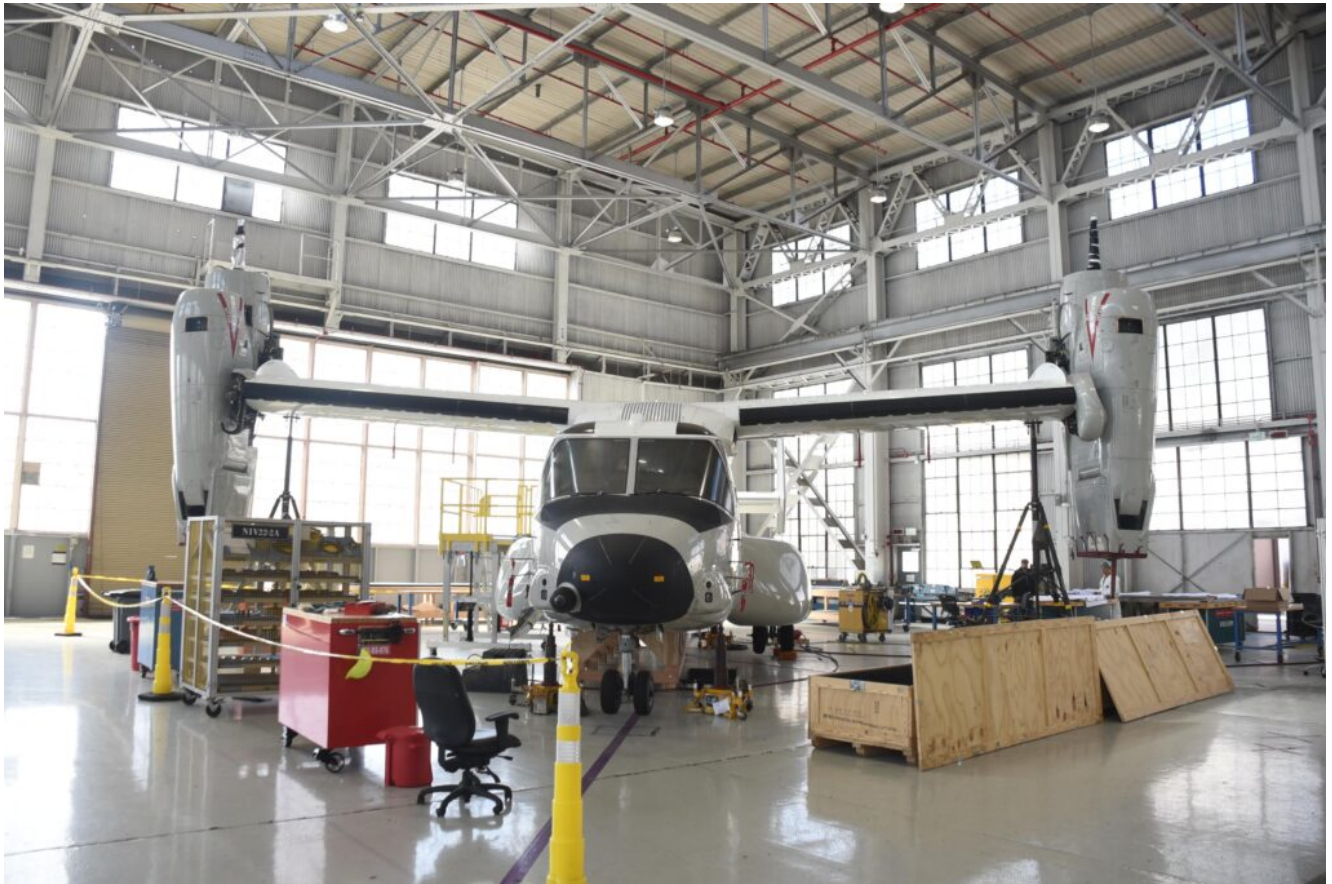
The VRM-30 CMV-22 Osprey inducted by FRCSW on January 13 is pictured in Building 333. The inner composite skin of the aircraft suffered a four-foot by two-foot crack during a mishap. FRCSW, FST, PMA-275 and industry partners developed a repair plan to return the aircraft to its squadron. *U.S. NAVY NAVAL AIR STATION NORTH ISLAND, Calif.* – Fleet Readiness Center Southwest artisans and the Fleet Support Team recently joined industry partners and the V-22 Joint Program Office (PMA-275) to prevent the loss of an CMV-22 Osprey aircraft which had suffered damage during a mishap, the center said March 8.

The right-hand inner composite skin of the \$75 million aircraft sustained a four-foot by two-foot crack with other, but minor, composite damage.

John Sandoval, sheet metal mechanic work lead, said the repair required replacing the inner skin panel.

"We've removed over 1,200 fasteners separated by over 42 feet of composite inner skin to composite outer skin," he said. "This proved to be difficult because this is the first of its kind repair."
